NATURAL HERITAGE REPORT

TESTON ROAD FROM 250 M WEST OF PINE VALLEY DRIVE TO KLEINBURG SUMMIT WAY

LGL Project # TA9006

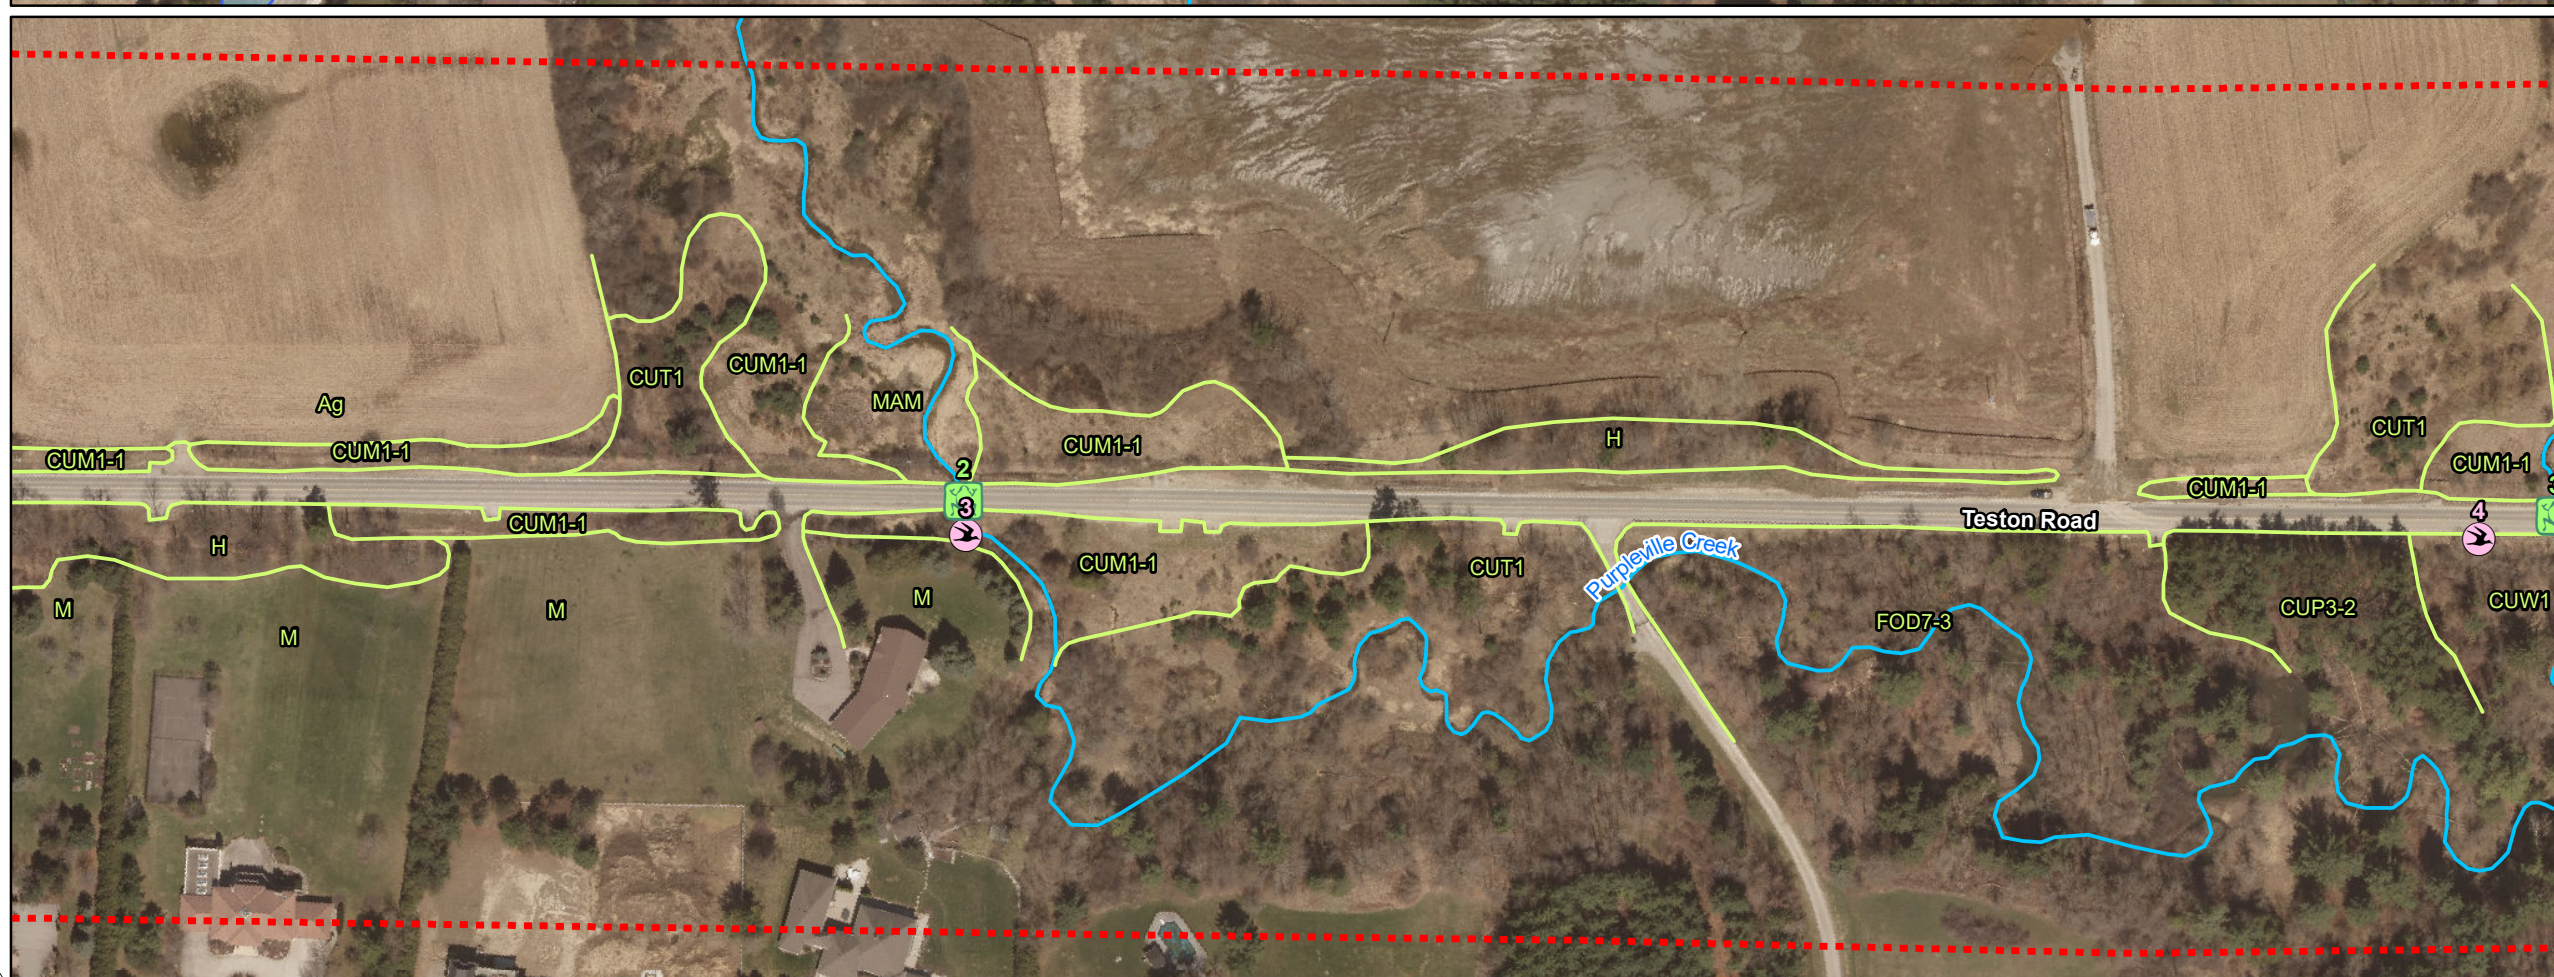
FIGURE 3A. TERRESTRIAL ECOLOGY

Vegetation communities located within the study area consist of a mixture of wetland, forest and cultural communities. A total of eleven Ecological Land Classification (ELC) vegetation community types were identified within the study area including: Open Aquatic (OAO), Mineral Shallow Marsh (MAS2), Meadow Marsh (MAM), Mixed Forest (FOM), Fresh-Moist Poplar-Sassafras Deciduous Forest (FOD8), Fresh-Moist Lowland Willow Deciduous Forest (FOD7-3), Coniferous Forest (CUP3), White Pine Coniferous Forest (CUP3-2), Dry-Moist Old Field Meadow (CUM1-1), Mineral Cultural Woodland (CUW1), and Mineral Cultural Thicket (CUT1). All of the vegetation communities identified within the study area are considered widespread and common in Ontario and are secure globally. These communities are delineated in **Figures 3a, b** and described in **Table 3**.

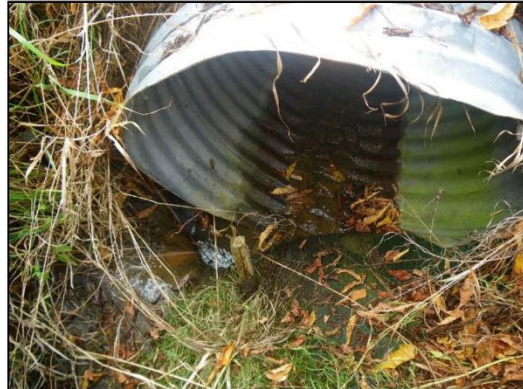
Upstream (north) end of CSPA culvert under Teston Road. Note staked filter sock across inlet

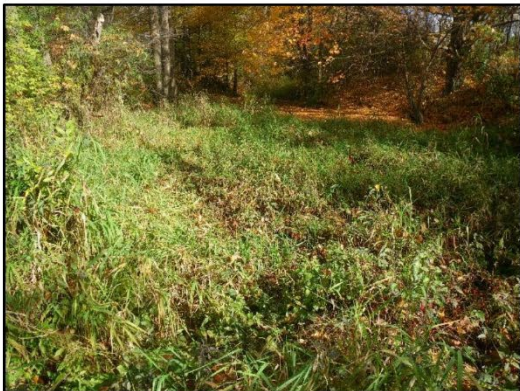
Facing upstream (north) at watercourse where it comes through valley to roadside ditch. Note wide flat wetland – no channel here

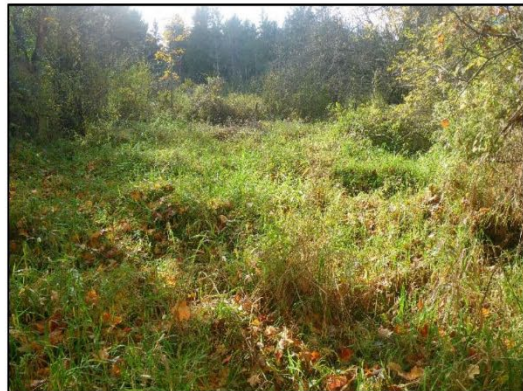
Upstream in flat wetland facing downstream (south) toward road and ditch. No channel – water spread through vegetated area

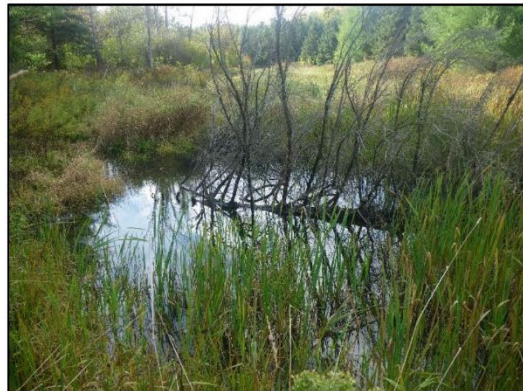
Pool below first elevation drop. Flow from this pool leads to another pool, followed by a large elevation drop into diffusely-flowing wetland swale. Facing downstream (south)

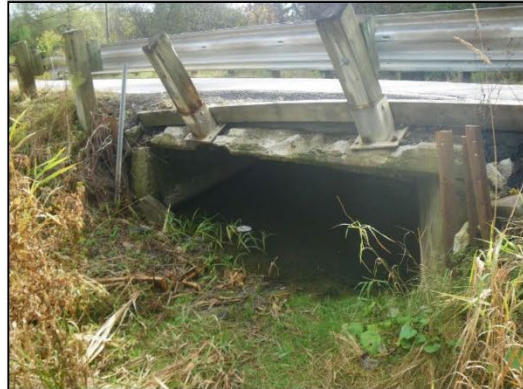
Upstream end of culvert at Crossing C2 facing downstream (southeast). Note pool of standing water inside culvert and dry channel upstream

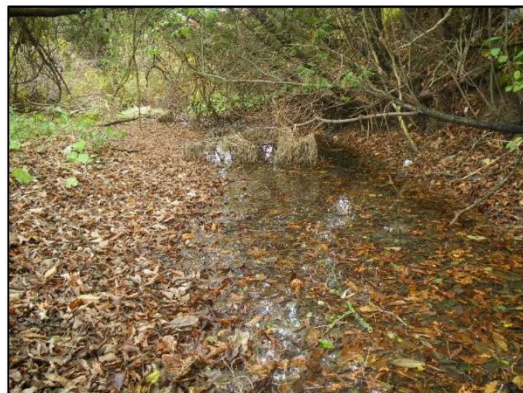
Downstream channel facing downstream (south). Note eroding bank to right

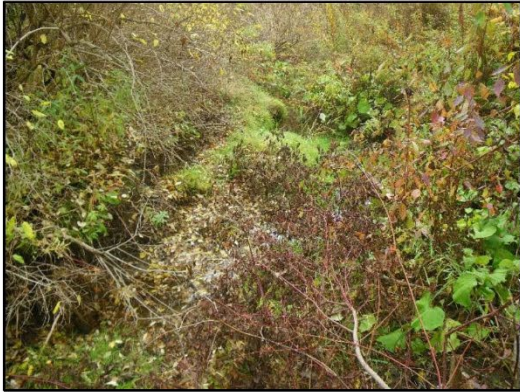
Downstream channel facing downstream (south). Note eroding banks and hummocks of grasses and soil

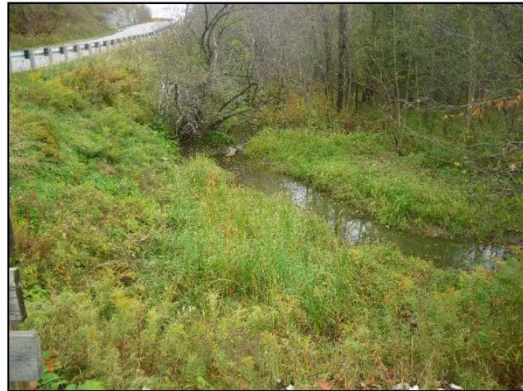
Channel where meander abuts road slope. Facing downstream (east). Teston Road in upper left

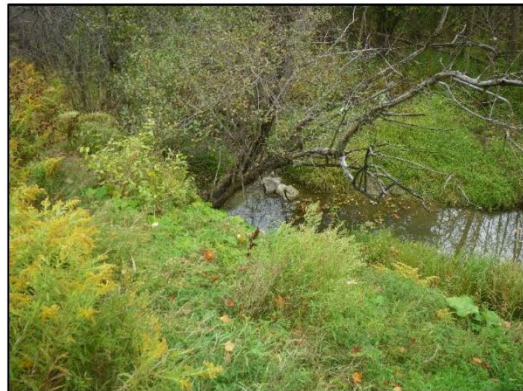
Facing down the steep Teston Road slope at point where watercourse abuts. Facing south

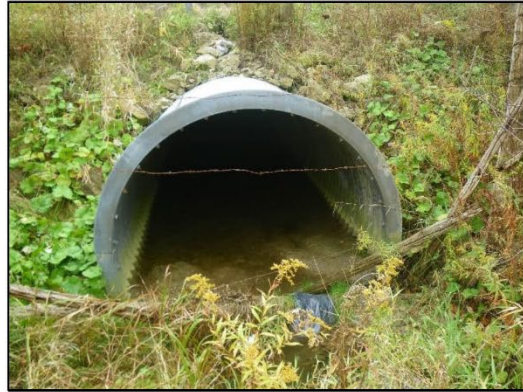
Upstream end of culvert facing downstream (south).
Note obstruction from wooden fencing material

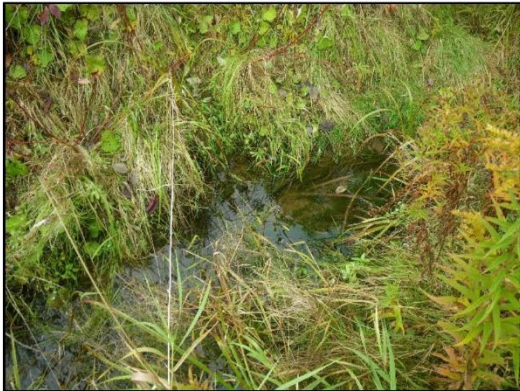
Typical section of channel upstream of Teston Road crossing.
Note narrow, shallow flow through dense vegetation

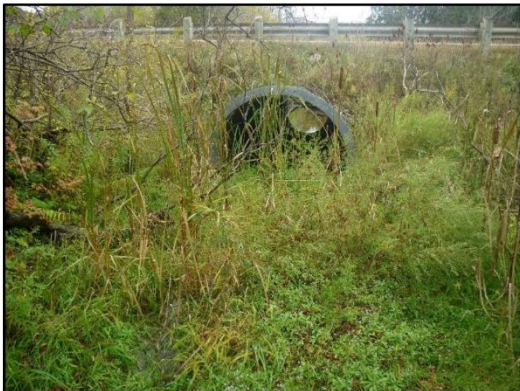
Downstream end of culvert facing upstream (north). Note
narrow channel in foreground

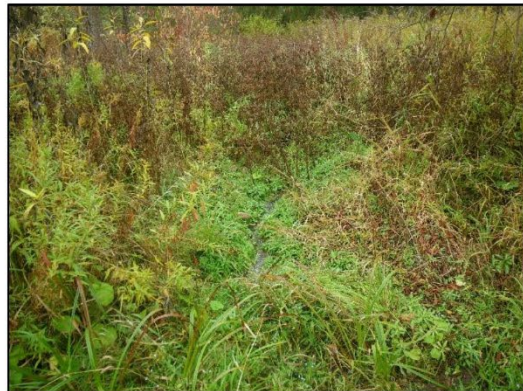
Channel downstream of crossing. Note very narrow
dimensions through wetland vegetation. Facing
downstream (south)

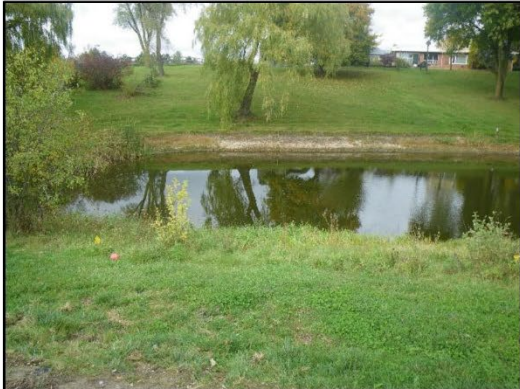
Upstream pond from which water flows originate for the drainage feature crossing at Crossing C4. Facing north from Teston Road east of the crossing

This feature crosses Teston Road through a small diameter CSP culvert approximately 650 m west of Pine Valley Drive. It conveys water from a small dug pond located on the north side of Teston Road that overflows into the roadside ditch. At the time of the site visit, this pond exhibited low-water conditions and appeared to be at least 1.5 m below its high-water level, as evidenced by the bare banks. The ditch and culvert were dry during the site visit and there was no evidence of recent flows. Downstream of the

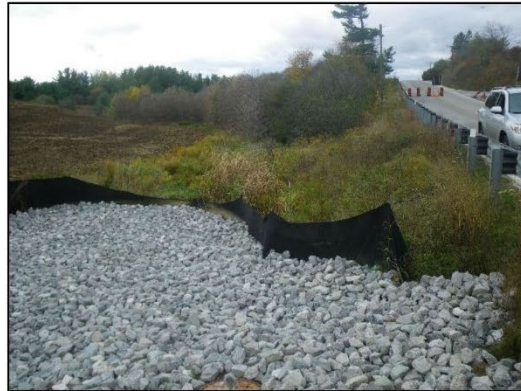
Swale downstream of culvert (outlet adjacent to cattails in center of photo). Note rip rap associated with a future storm water facility outlet. Facing downstream (west)

crossing, any drainage that is conveyed across the road travels down a relatively wide, grassy swale toward the tributary of Purpleville Creek that crosses at Crossing 3. The slope is relatively steep here and there is no defined channel. It is likely that this feature conveys surface drainage and pond overflow only. It was noted that the large land development that is occurring to the east has an outlet just to the east of the crossing on the south side of Teston Road. As such, this feature will receive input from storm water management facilities within this development in the future.
