Arborist Report

TESTON ROAD FROM 250 M WEST OF PINE VALLEY DRIVE TO KLEINBURG SUMMIT WAY

NOVEMBER 2022

LGL FILE TA9021

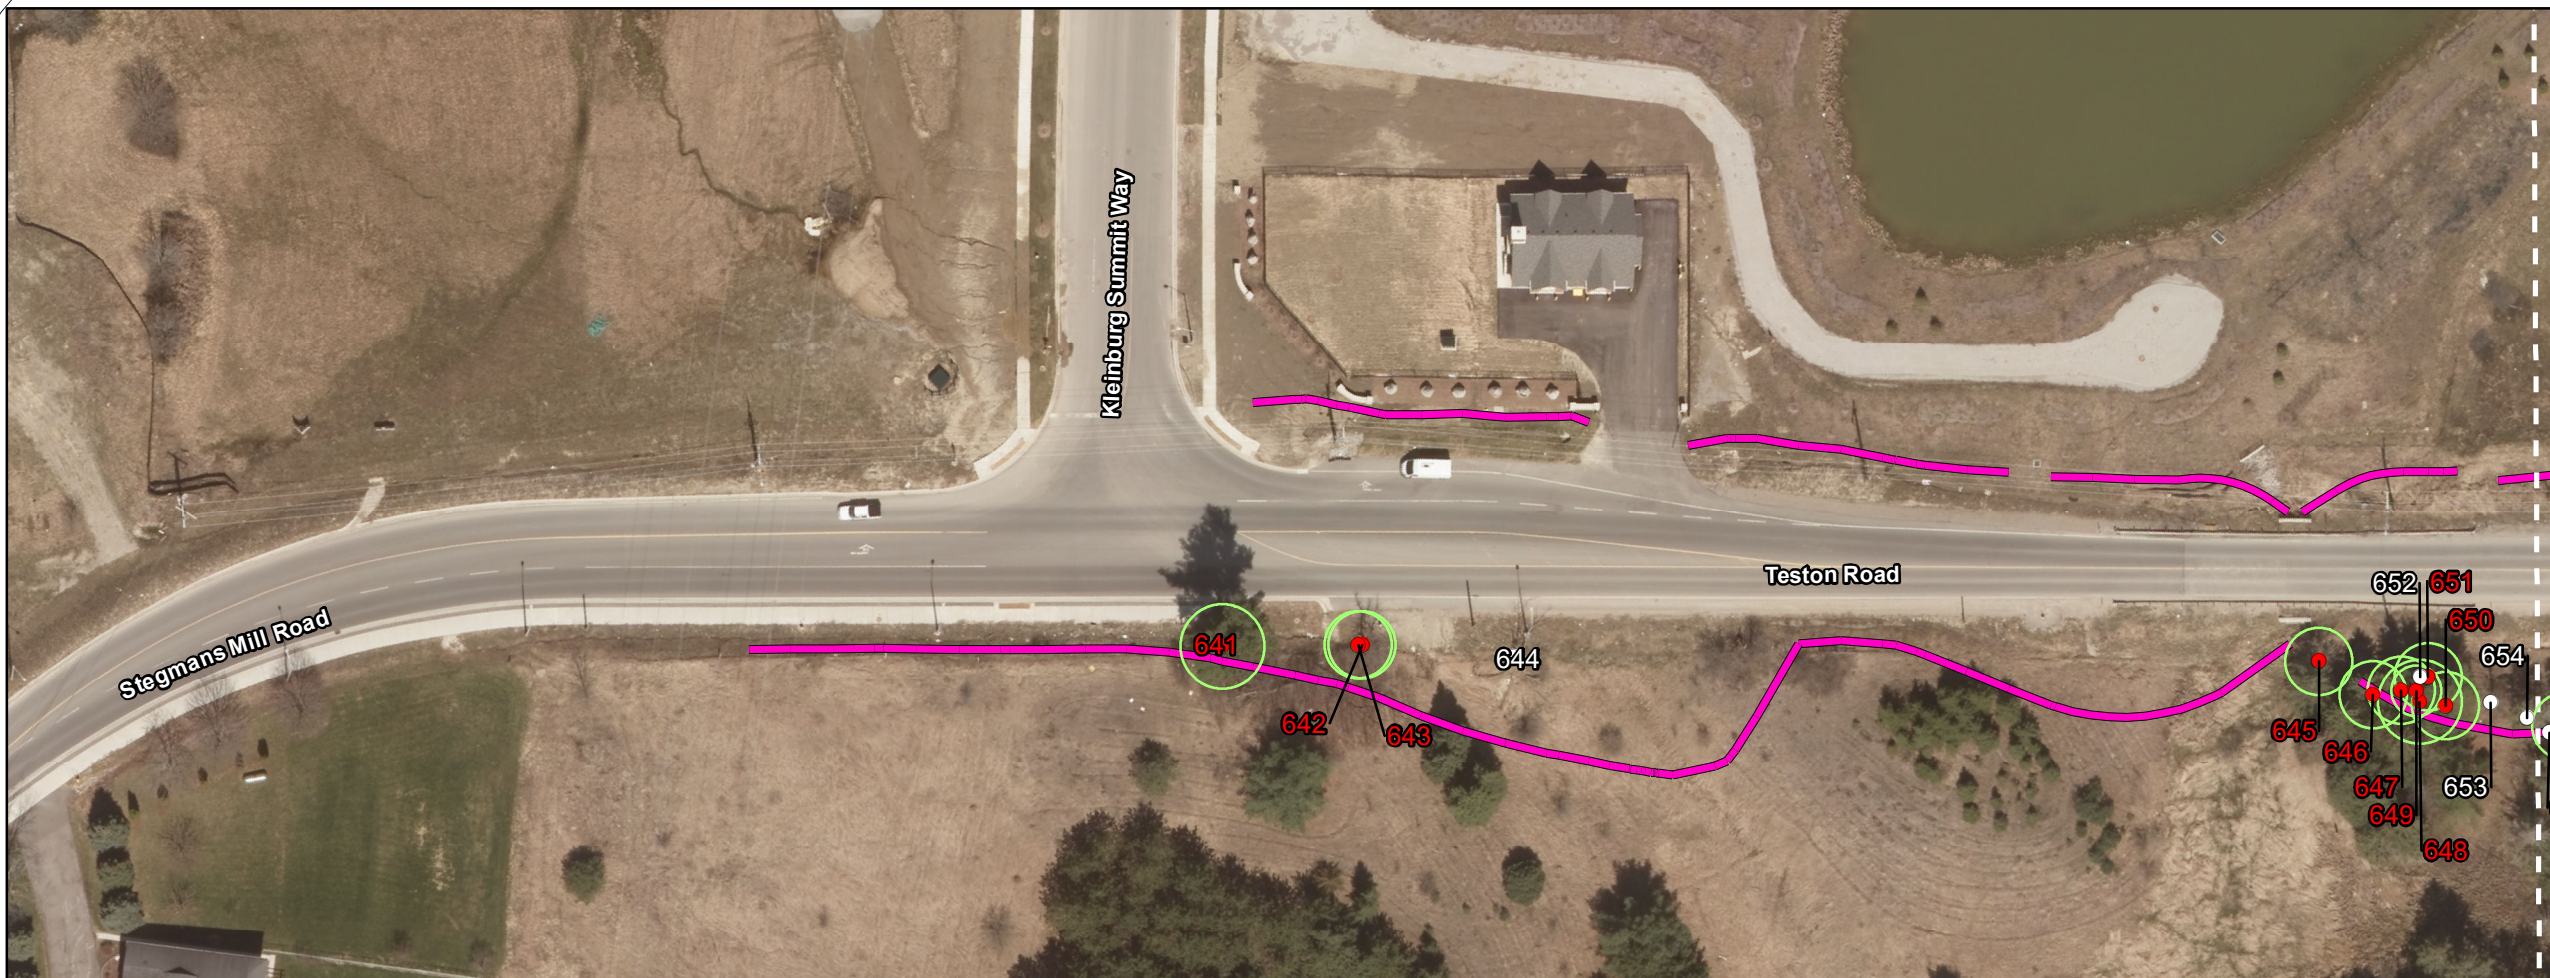
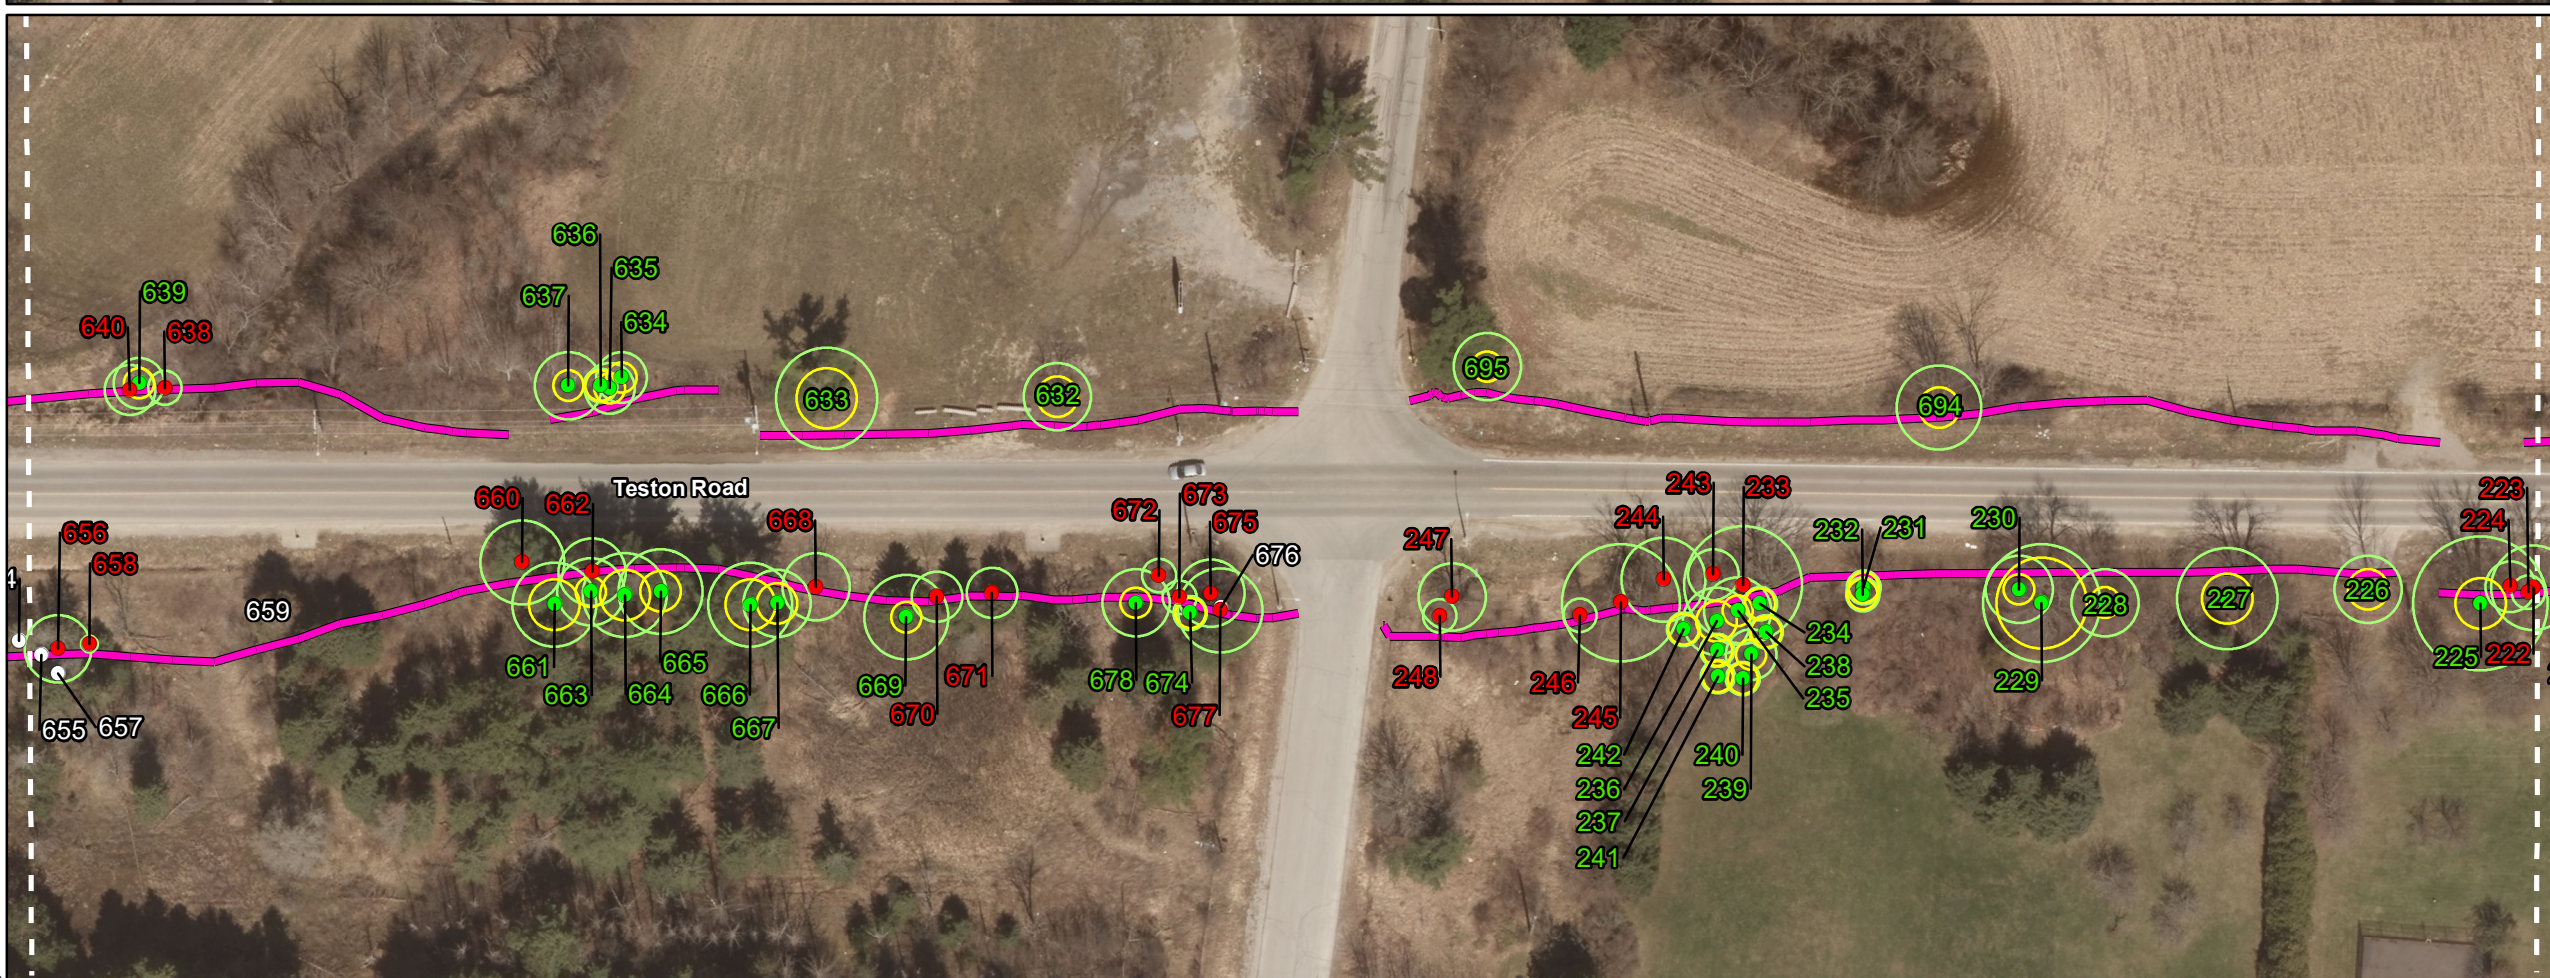
Project: TA9006	Figure: 2a
Date: November, 2022	Prepared By: AM
Scale: 1:900	Verified By: LMC

A total of 179 trees consisting of 24 species were identified and assessed during the tree inventory. The majority of trees within the study area are part of larger forest communities that extend beyond the Teston Road ROW. A detailed summary of all trees surveyed is presented in **Appendix A** (Tree Inventory), and the locations of each tree (by identifier number) are presented in **Figures 2a to 2d**.

**Teston Road
Tree Resources**

Trees recommended for removal include trees within or outside the grading limit that would not be able to withstand construction related impacts. Alternatively, trees identified as retained are considered to be minimally affected by the proposed works and will be protected through mitigation measures to be implemented during construction. A detailed description of those trees identified for removal and retention is provided in **Sections 4.1 to 4.2** and presented on **Figures 2a to 2d**.

As noted in **Section 5.0**, trees identified for removal includes trees within the proposed disturbance limits and those trees outside of the disturbance limits where the amount of critical root zone that will be removed will likely cause significant and irreversible decline of the health of the tree. As such, a total of 72 trees have been identified for removal as a result of the proposed road improvements. Trees identified for removal and the reason for removal are listed in **Appendix A** and presented in **Figures 2a to 2d**.

A total of 107 trees have been identified for retention and listed in **Appendix A** and presented in **Figures 2a to 2d**.

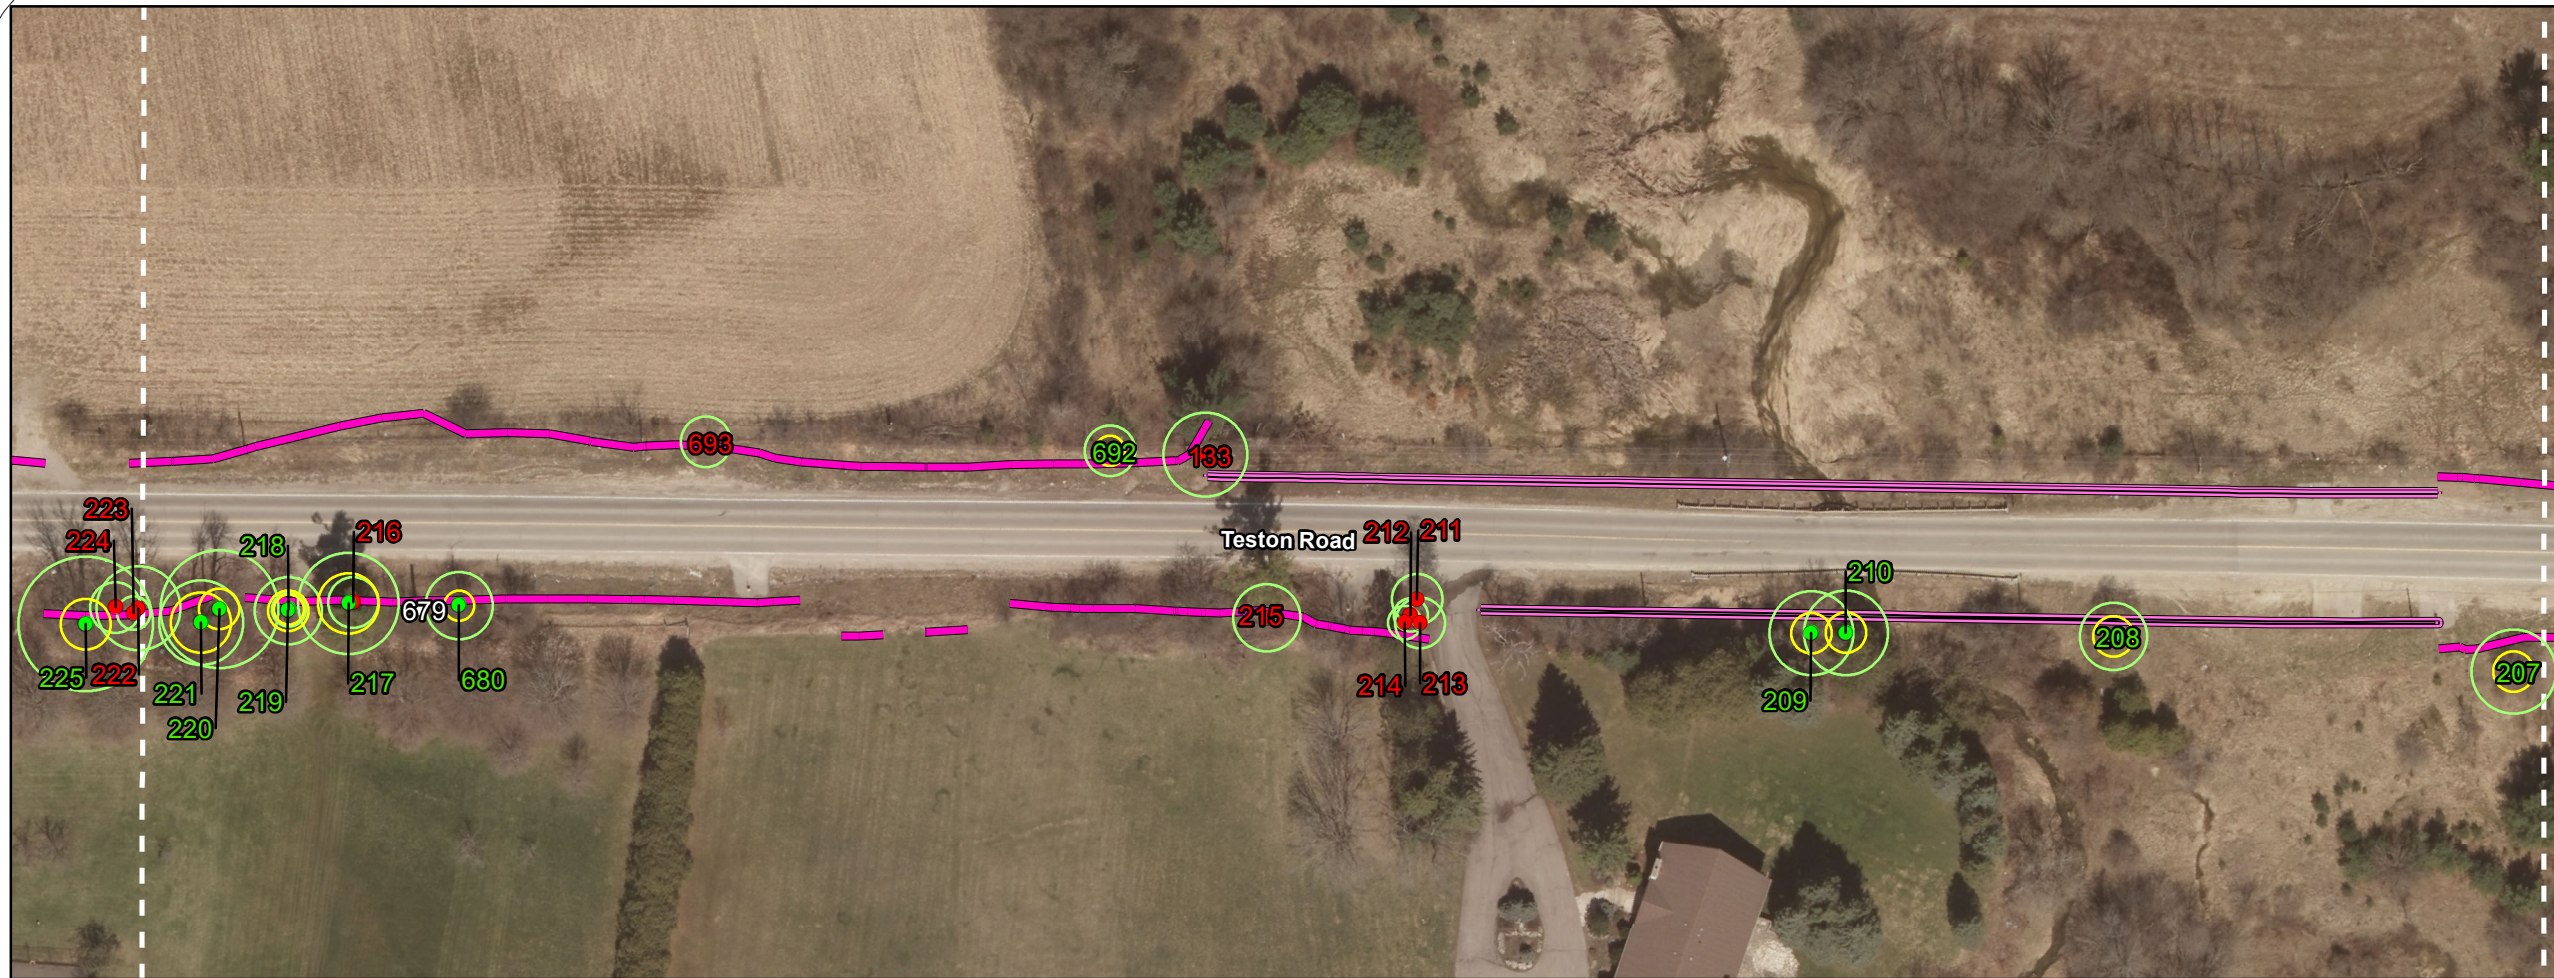
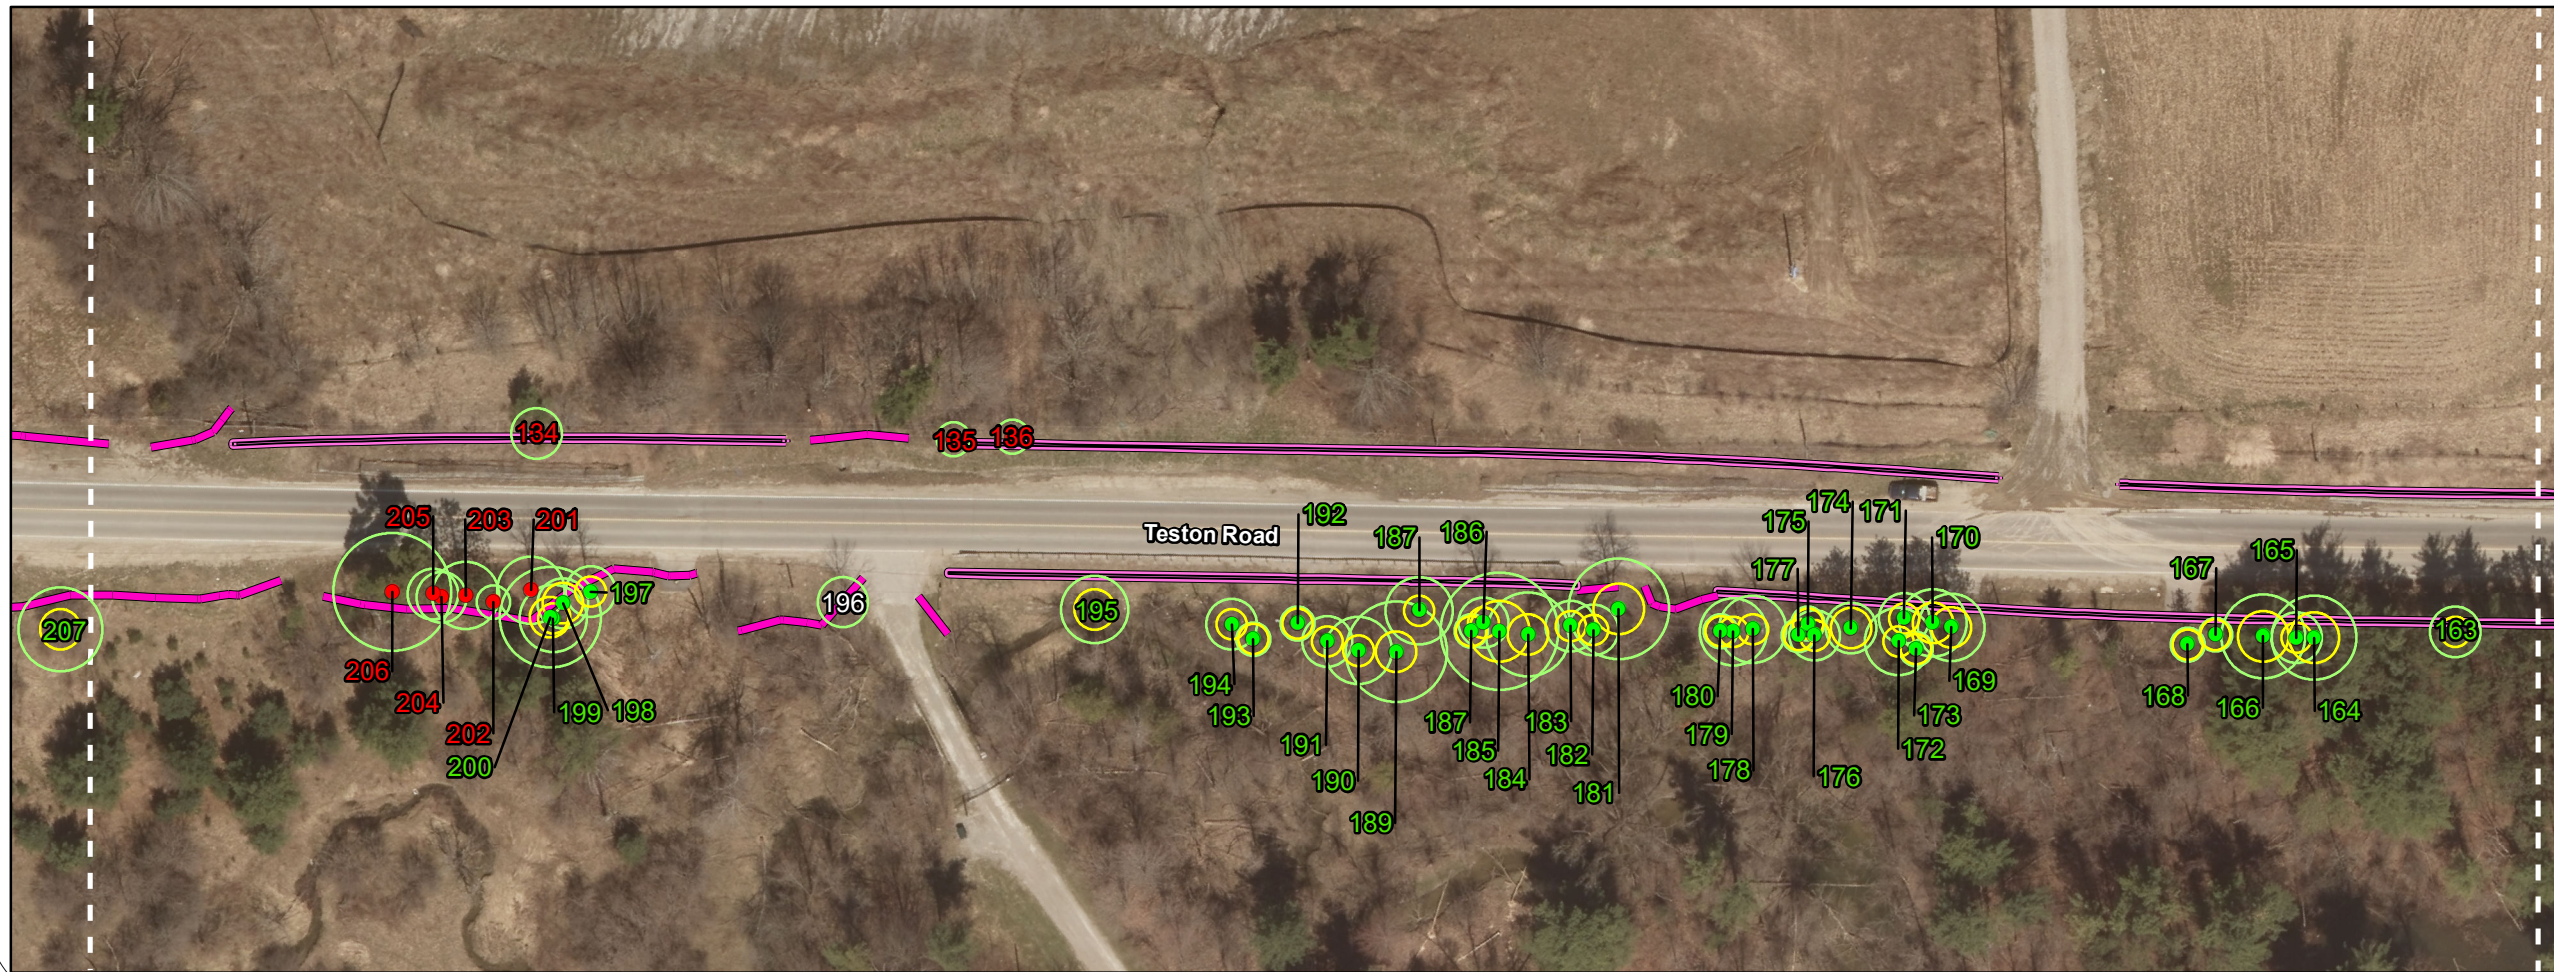
Project: TA9006	Figure: 2b
Date: November, 2022	Prepared By: AM
Scale: 1:900	Verified By: LMC

**Teston Road
Tree Resources**

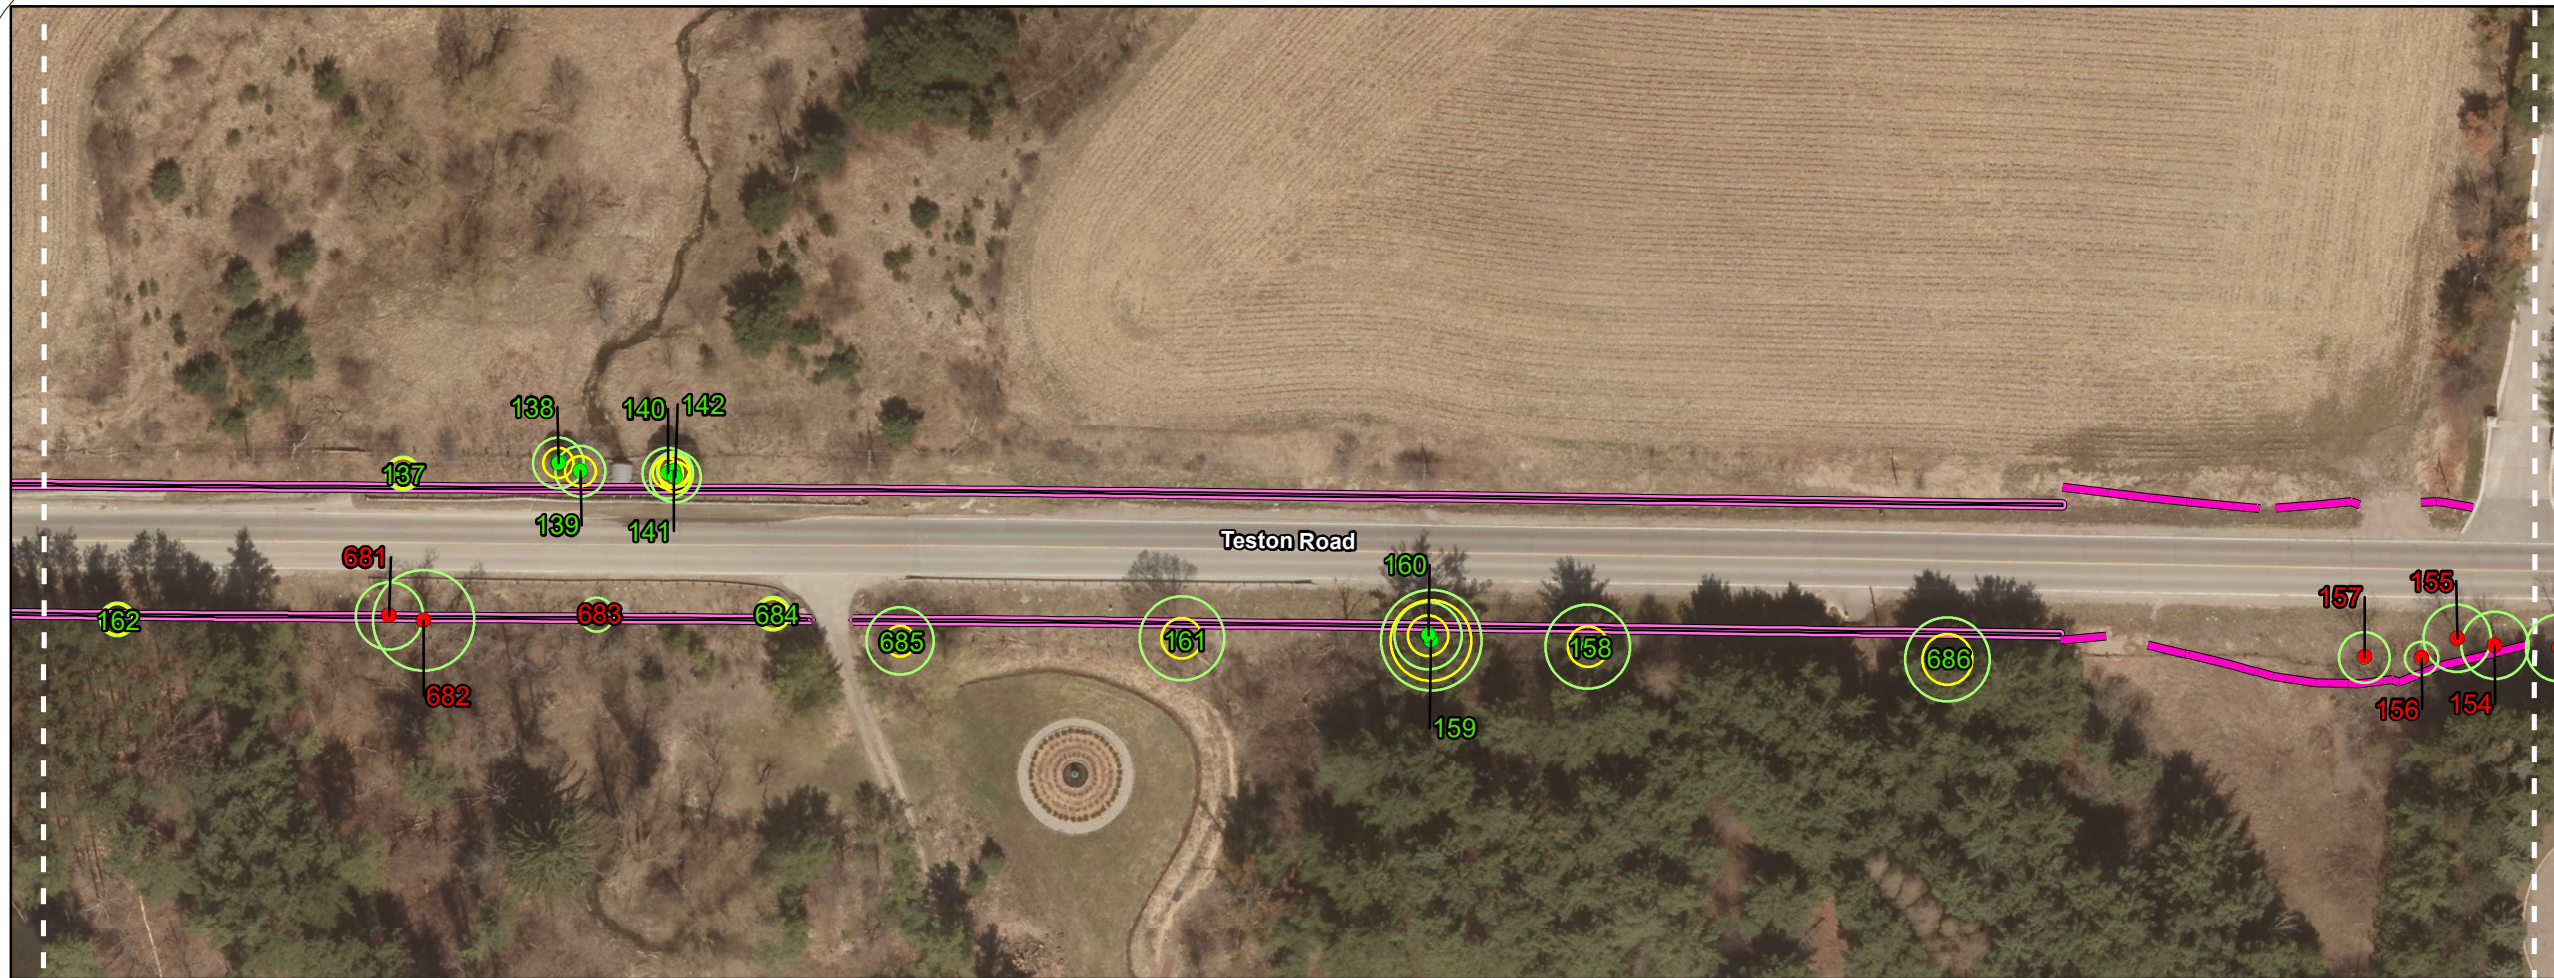
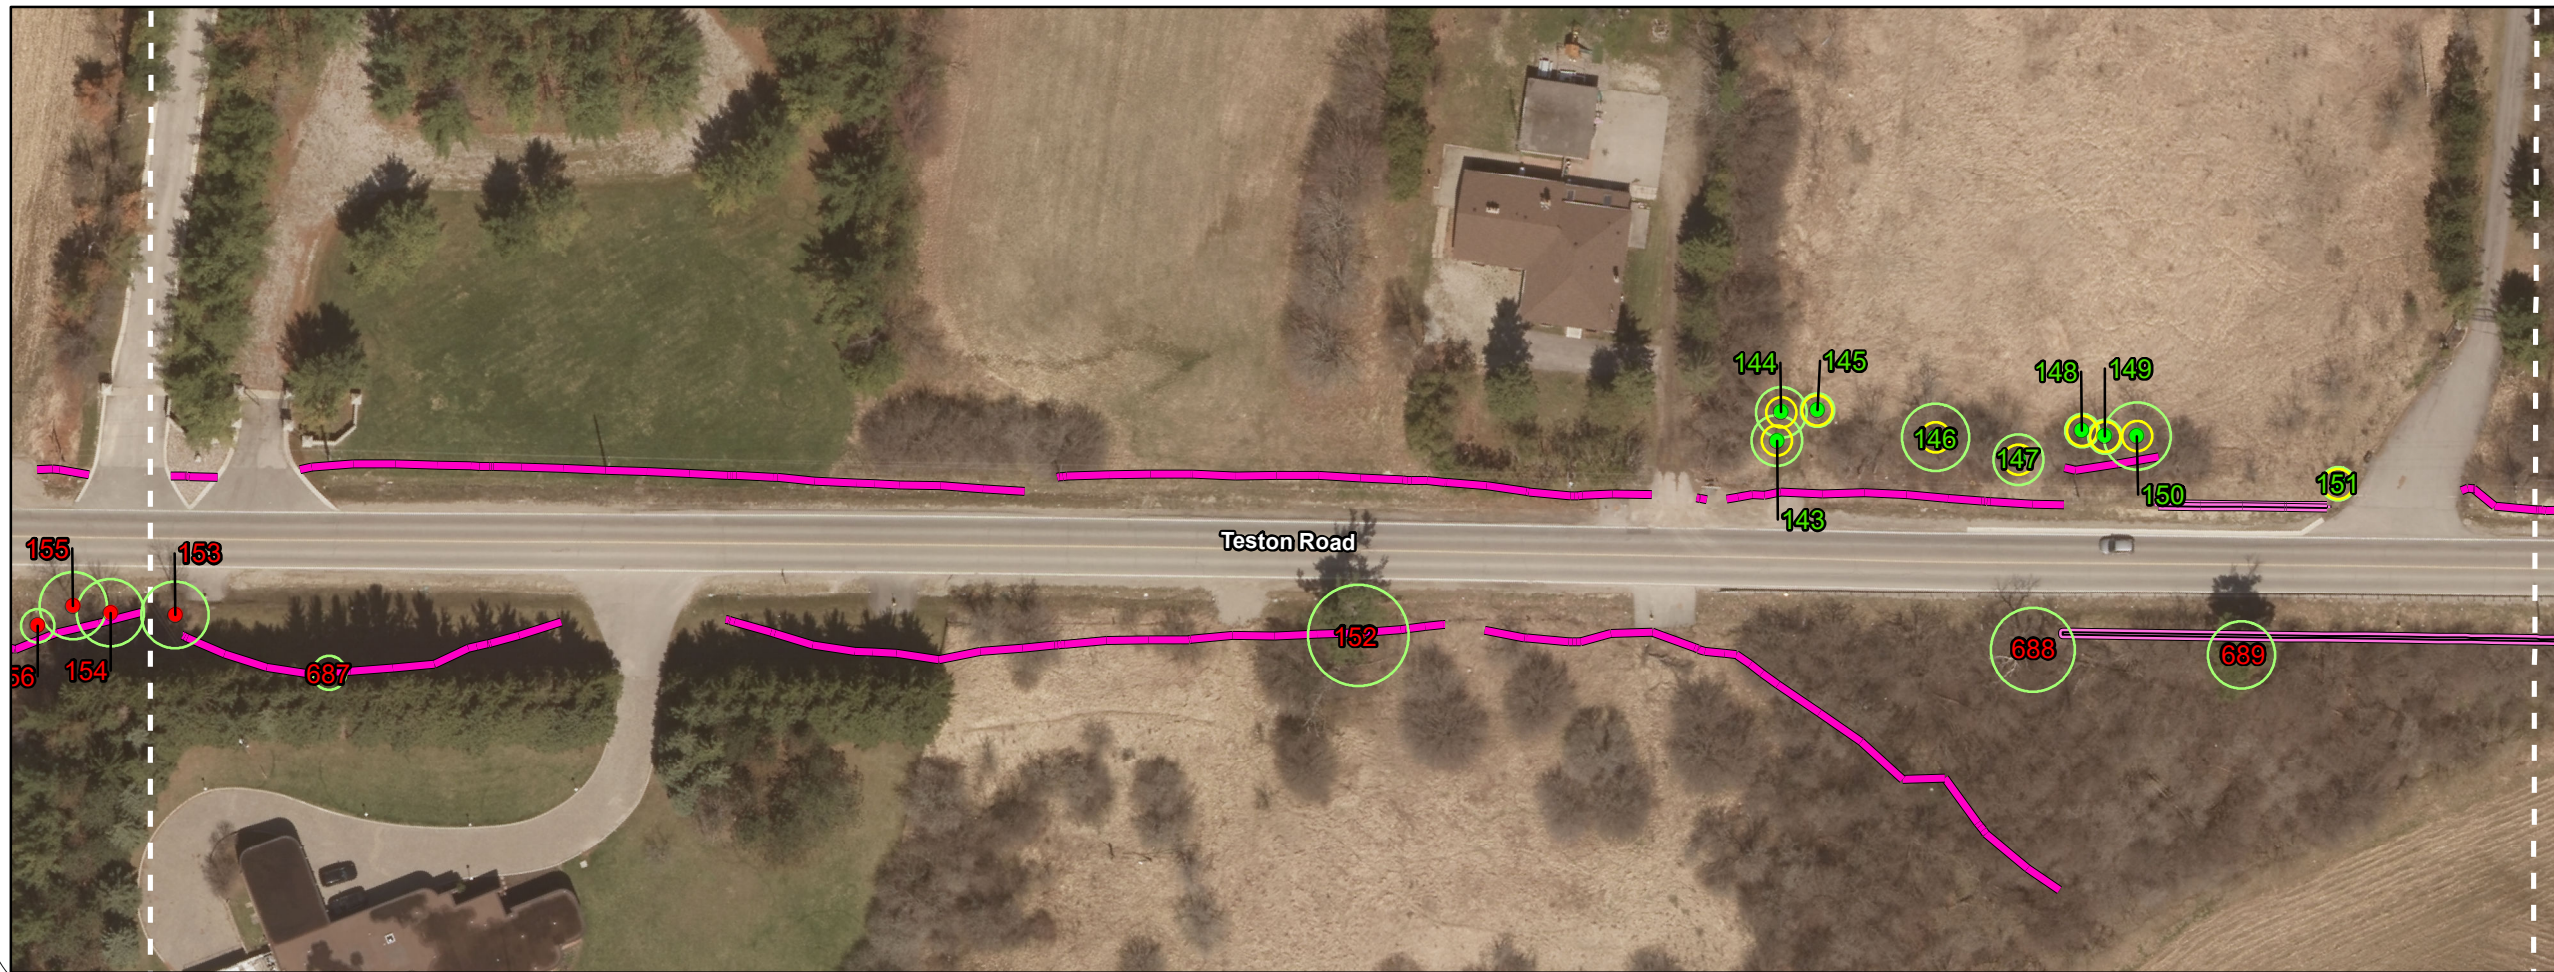
Project: TA9006	Figure: 2c
Date: November, 2022	Prepared By: AM
Scale: 1:900	Verified By: LMC

**Teston Road
Tree Resources**

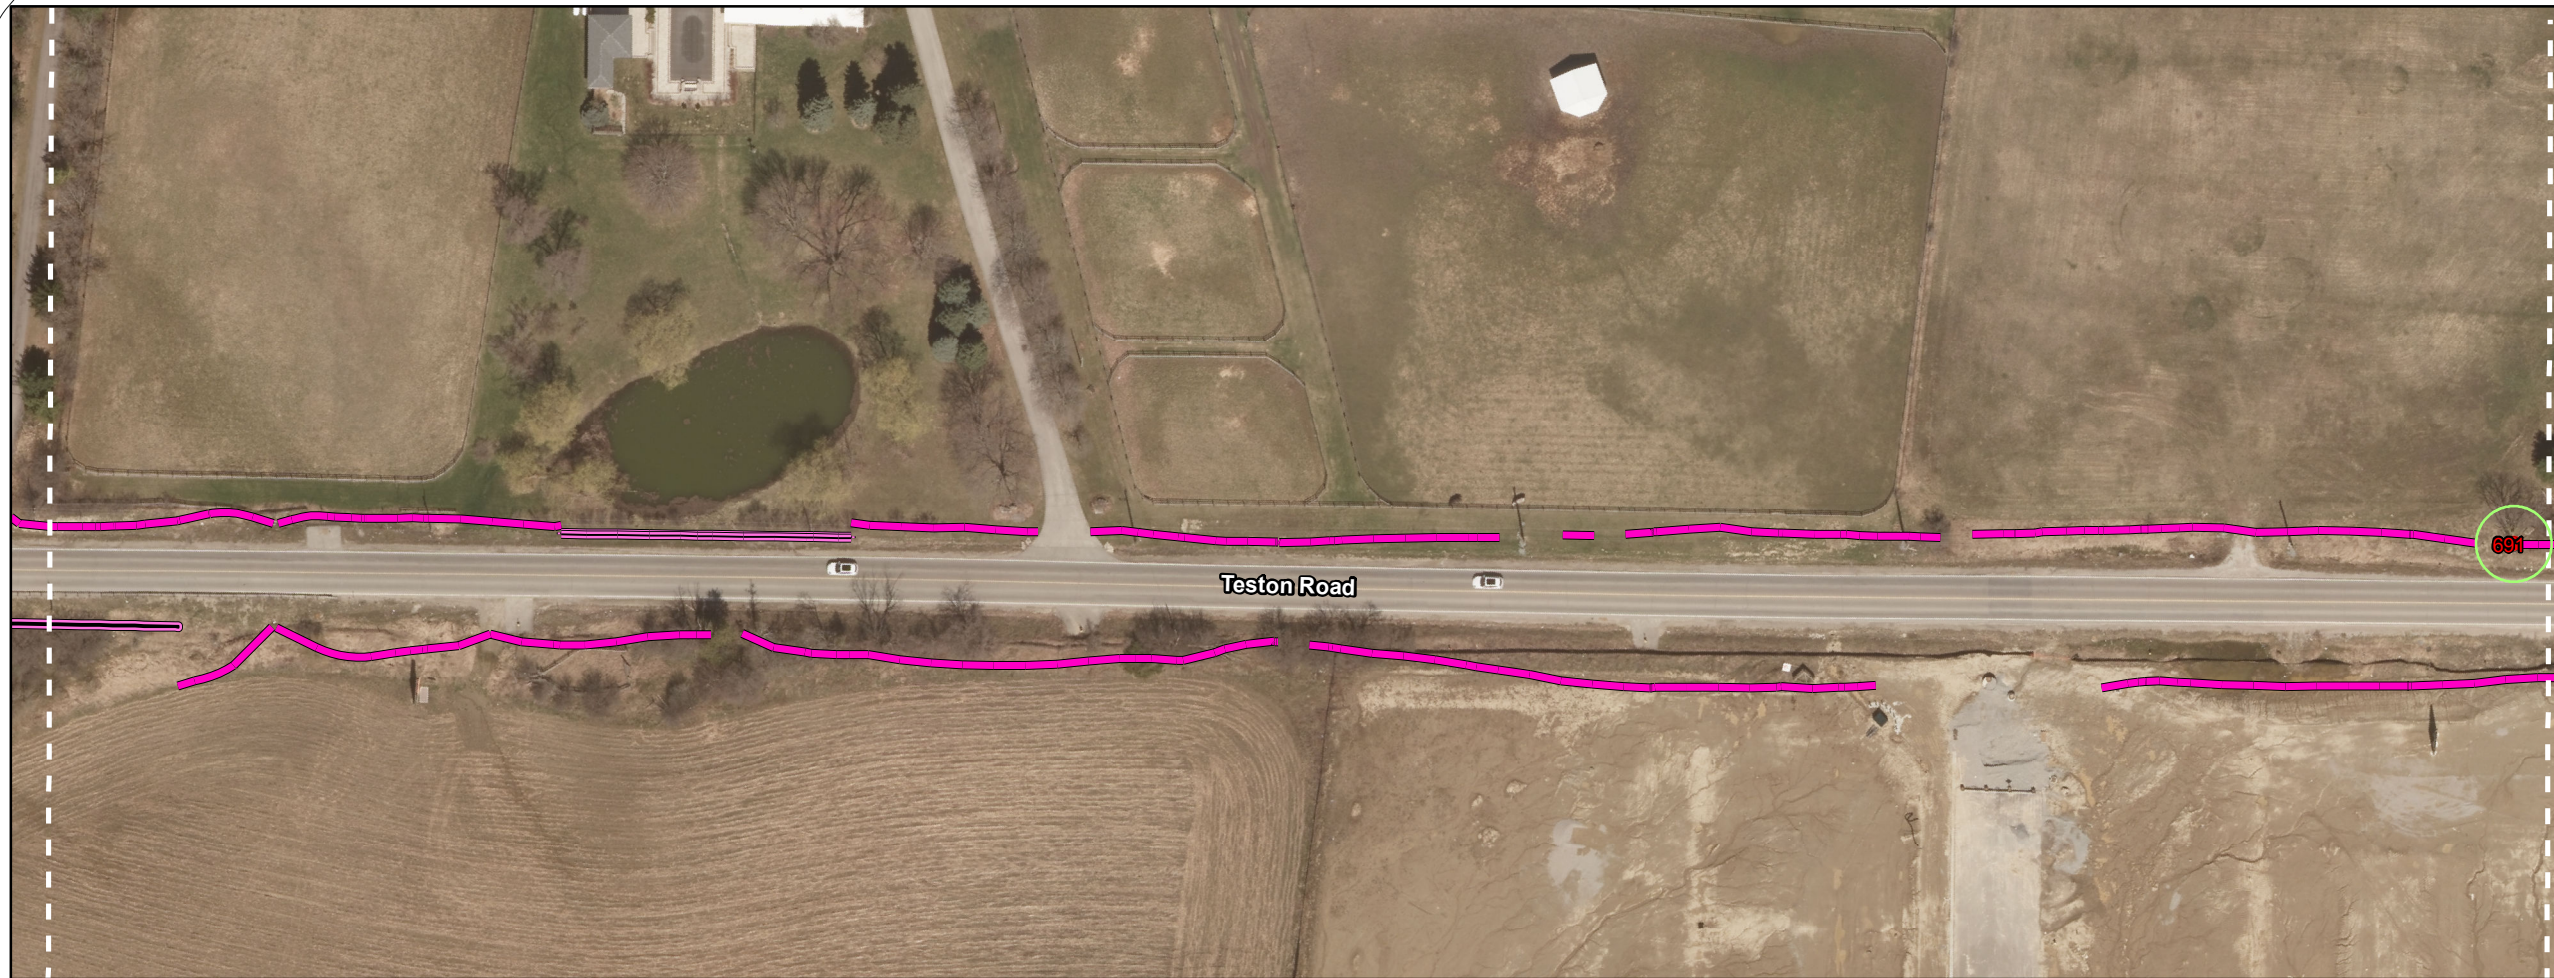
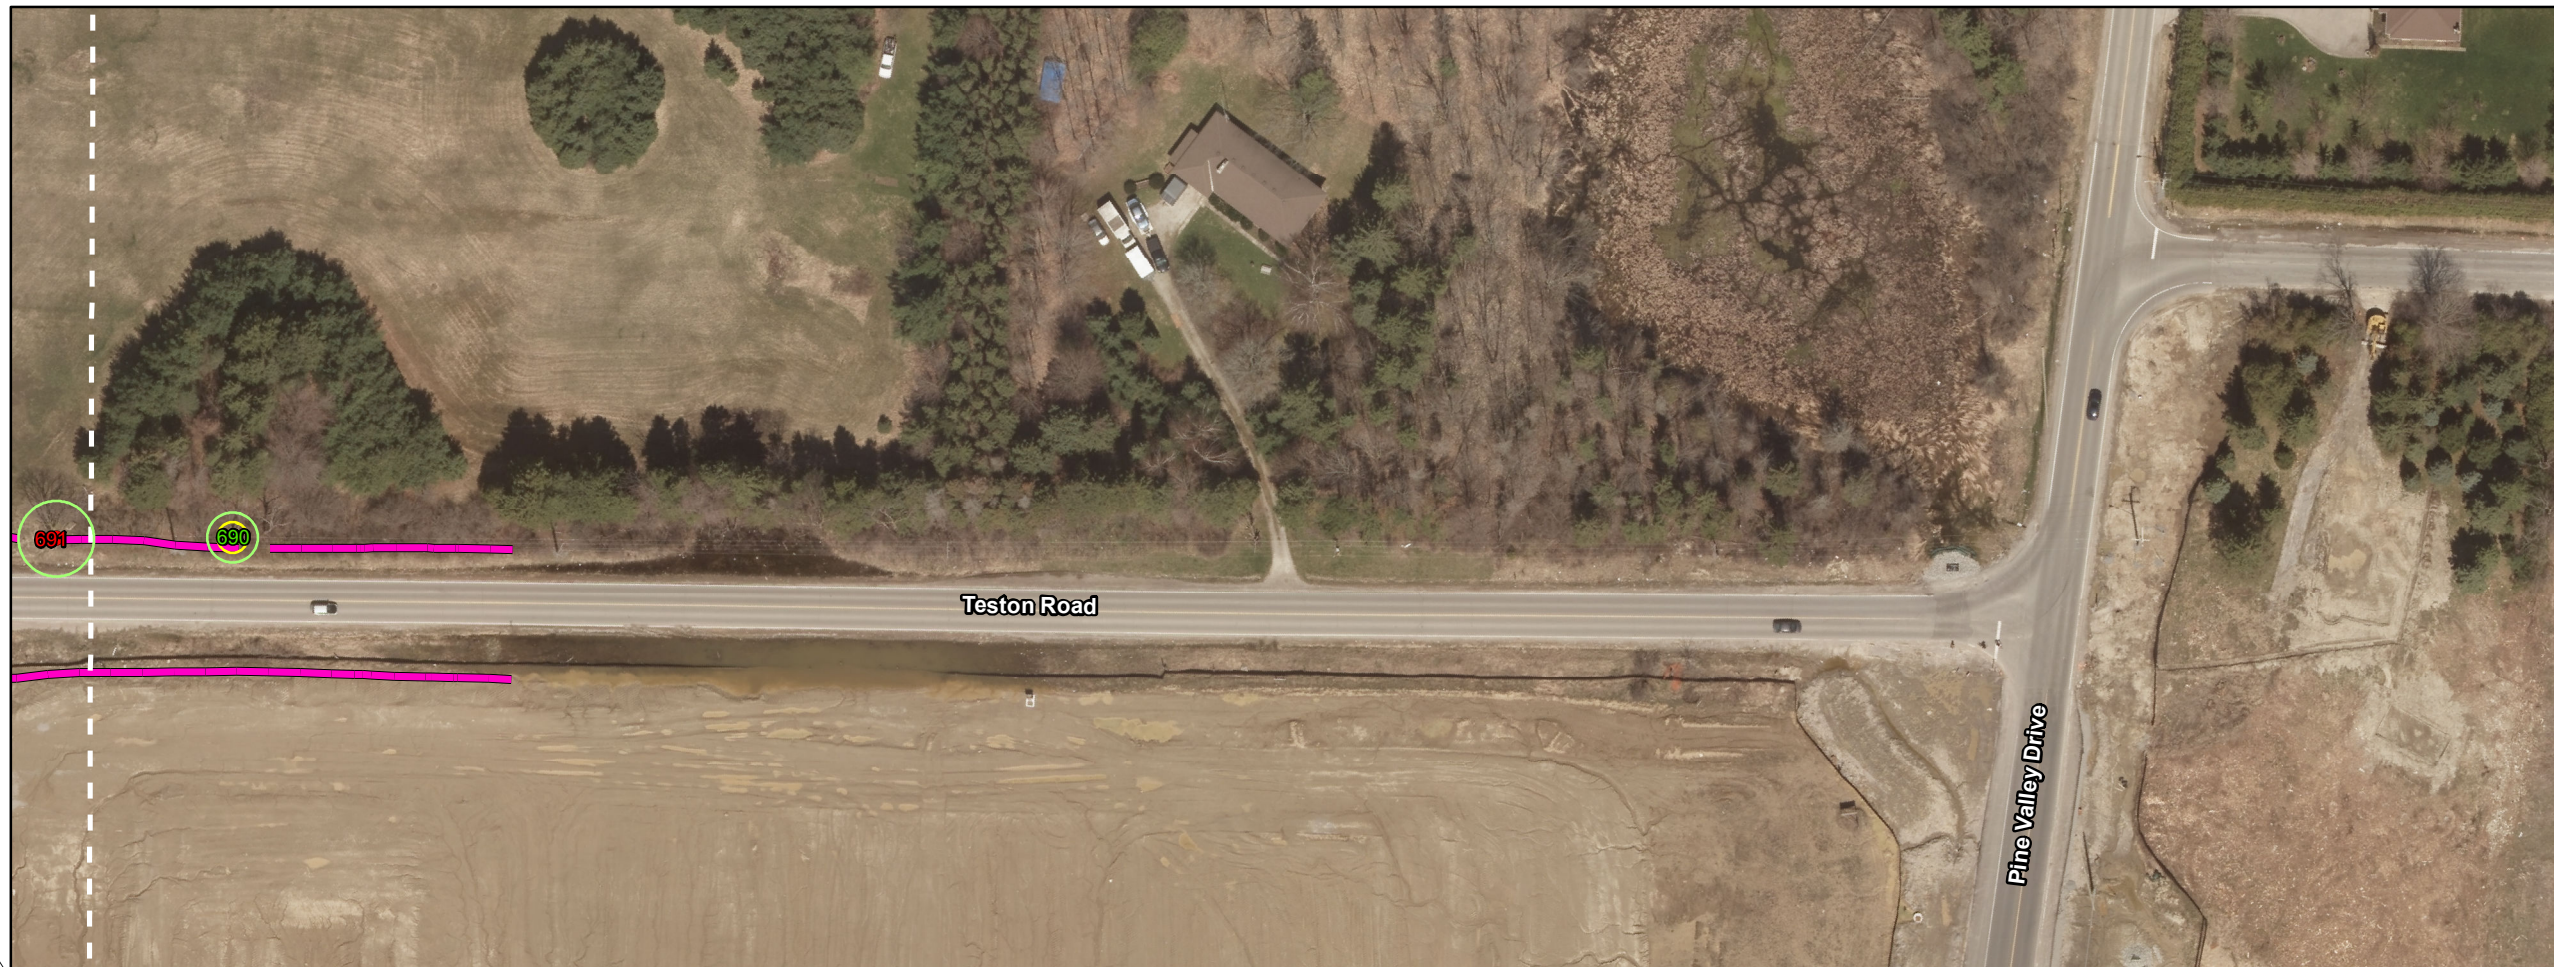
Project: TA9006	Figure: 2d
Date: November, 2022	Prepared By: AM
Scale: 1:1,200	Verified By: LMC

**Teston Road
Tree Resources**
