**THURBER** ENGINEERING LTD.

**CONTAMINATION OVERVIEW STUDY  
KIRBY ROAD WIDENING  
BETWEEN JANE STREET AND DUFFERIN STREET  
CITY OF VAUGHAN, ONTARIO**

**HDR Inc.**

Date: April 1, 2020  
File: 26130-20

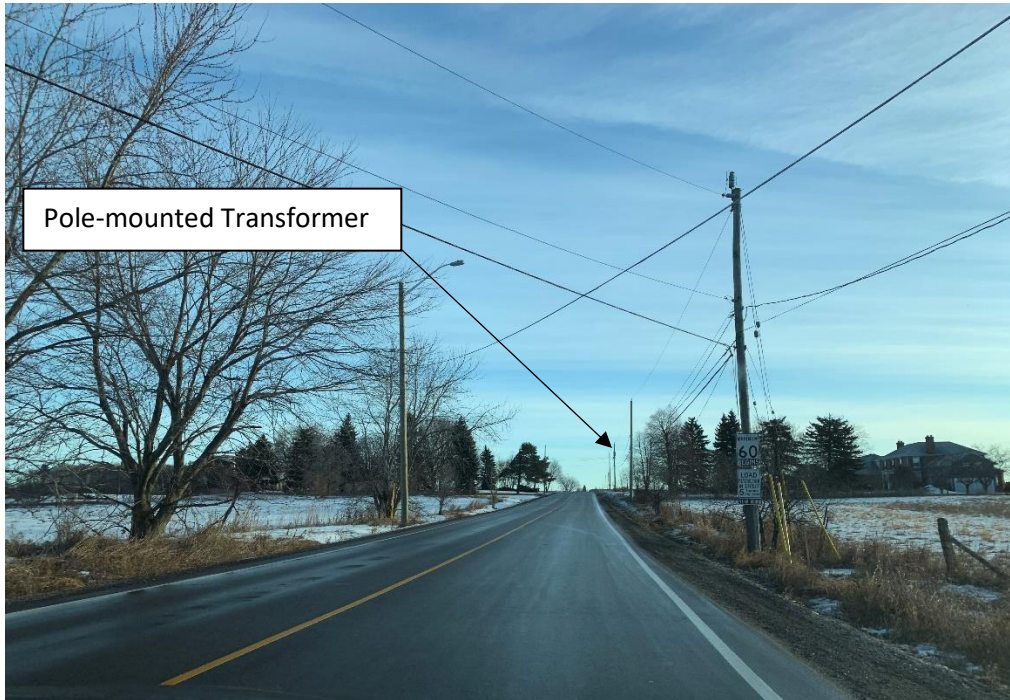
The Site alignment that extended between Jane Street and Keele Street appeared to have recently been re-paved and in good condition (Photo 1), whereas the section of road between Keele and Dufferin Streets appeared in fair to good condition with multiple patches.

Hydro poles with random pole-mounted transformers (Photo 1) generally existed along the south side of the road with occasional lateral overhead crossings, except for an approximate 500 m section to the west of 2480 Kirby Road (Golf Centre) where no hydro poles were observed. In addition, overhead hydro lines were routed along the north side of the Site alignment in an approximate 200 m section near and to the east of 2480 Kirby Road. Streetlights were observed on the south side of Kirby Road between Keele Street and Dufferin Street, and near the intersections with Jane Street, Keele Street and Dufferin Street.

Photo 1: View to the east on Kirby Road from near the intersection of Jane Street. Hydro poles and pole mounted transformers existed on the south side of the road.

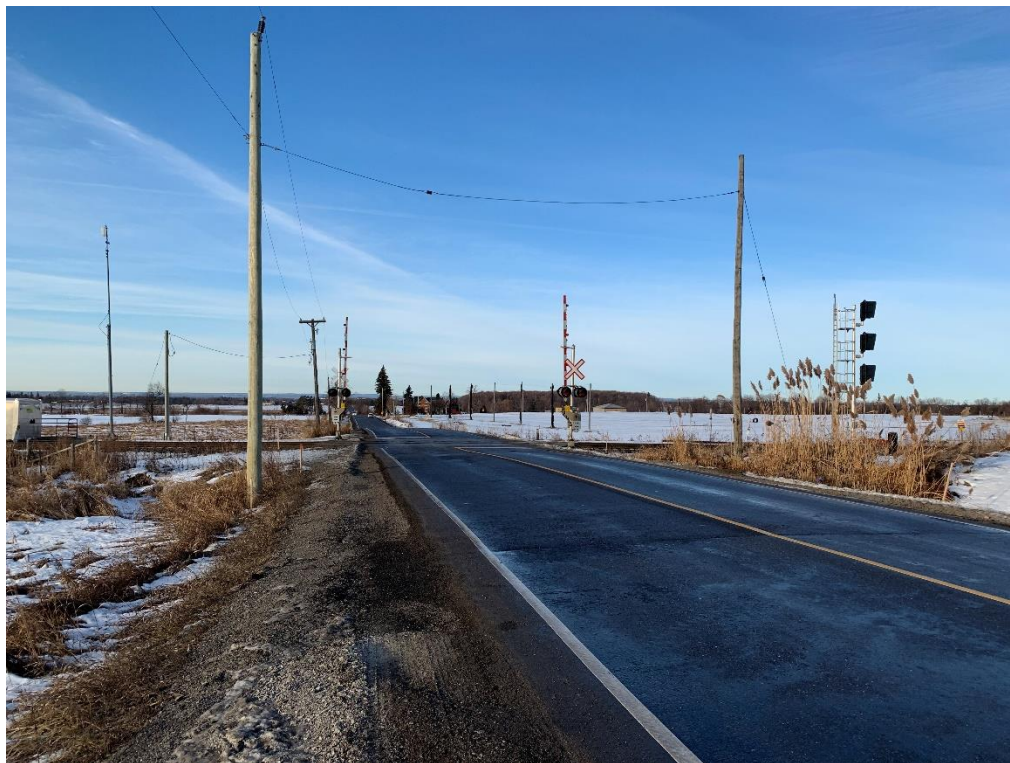
No staining or evidence of spills were observed near the railway line that crosses the Site in a north-south direction to the west of Keele Street. However, the ground surface in the adjacent ditches near the crossing was covered by grass, vegetation and snow which limited an assessment of the ground conditions.

Photo 2: View to the west on Kirby Road at the Barrie Go railway line crossing Kirby Road in a north-south direction.

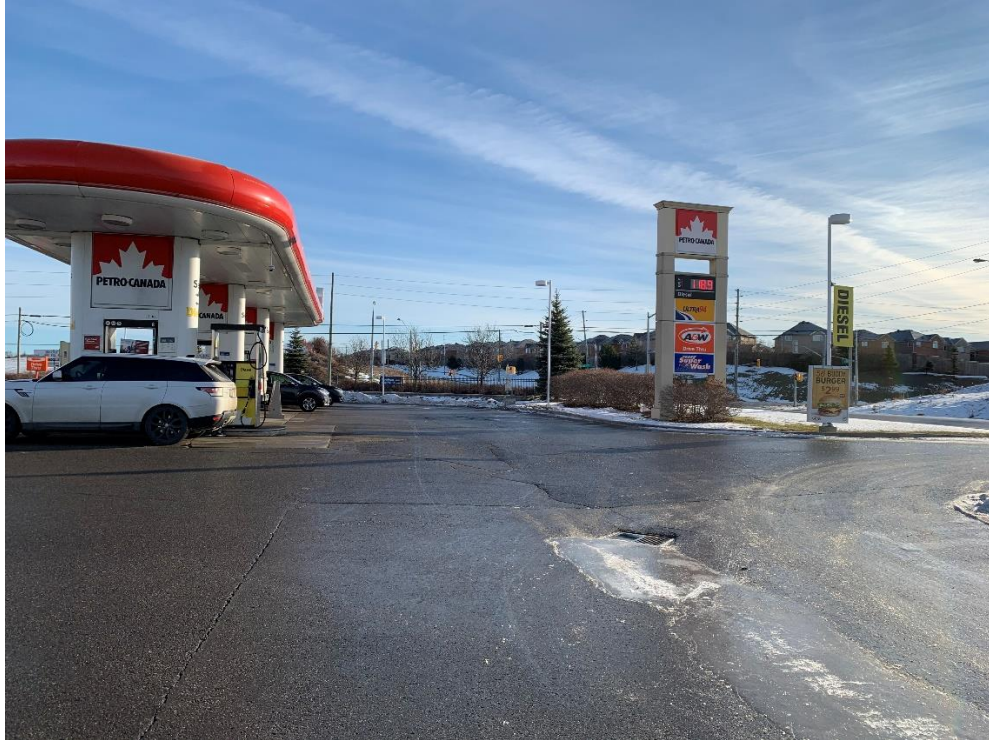
No aboveground storage tanks were observed from publicly accessible areas during the Site visit, other than random propane tanks that likely provide a fuel source for the associated houses. However, underground fuel storage tanks (USTs) would exist at the gas station that is located at the northwest corner of Keele Street and Kirby Road.

Photo 3: A view to the west at the Gas Station located at 11600 Keele Street (on the northwest corner of the intersection of Keele Street and Kirby Road).

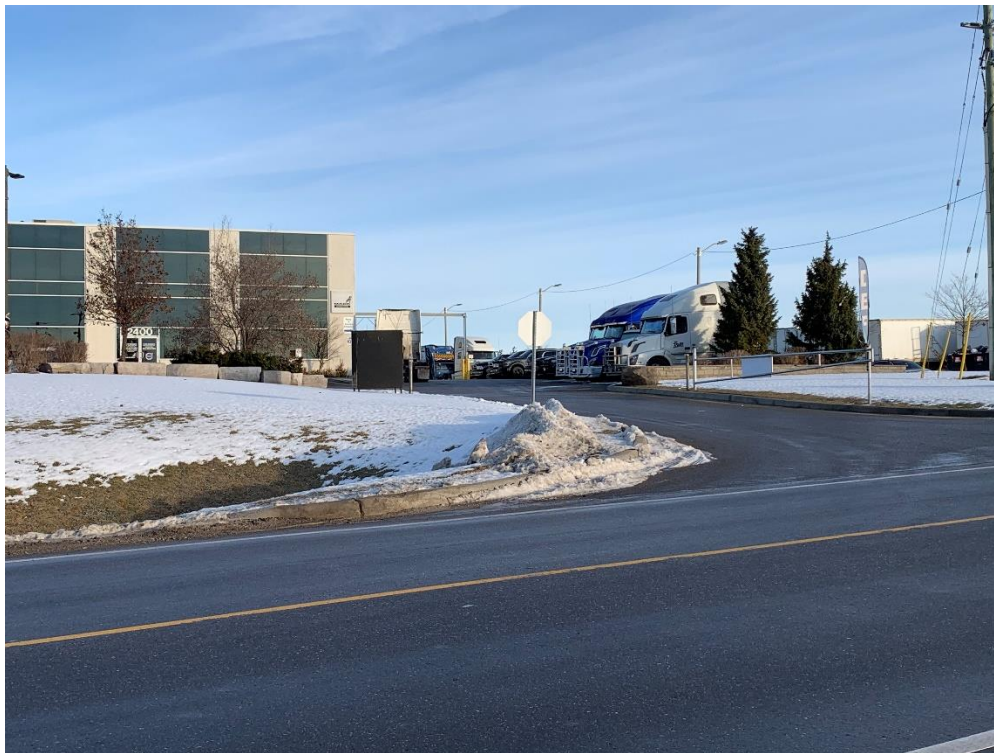
Photo 4: A view to the north from Kirby Road at the Truck Centre located at 2400 Kirby Road.

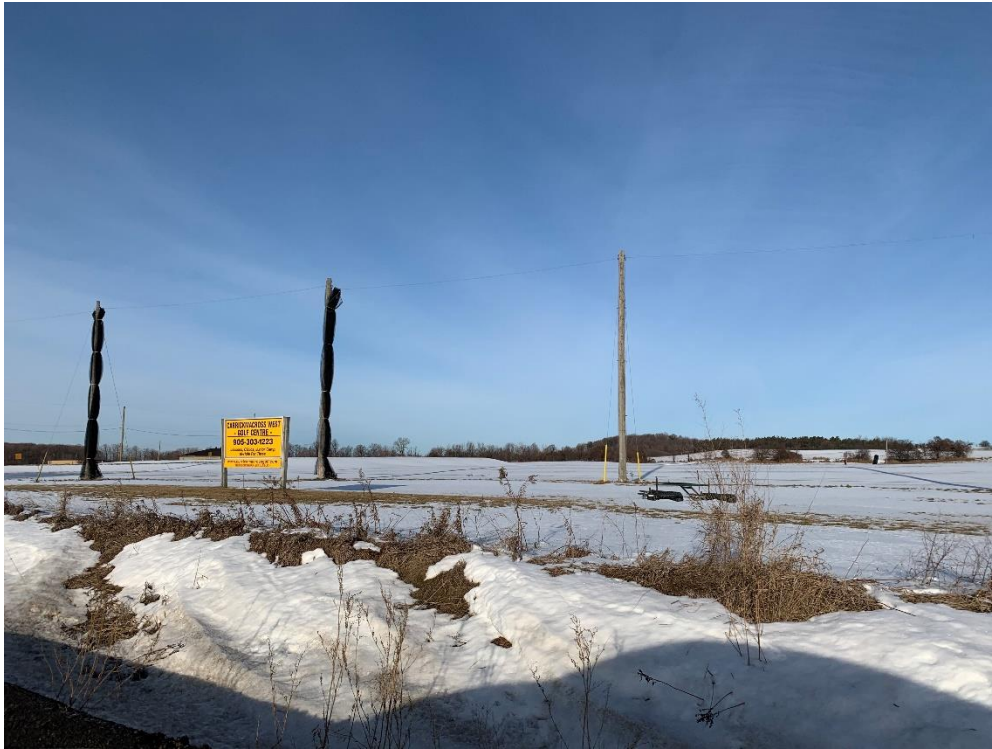
Photo 5: A view to the northwest from Kirby Road at the Golf Centre located at 2480 Kirby Road.

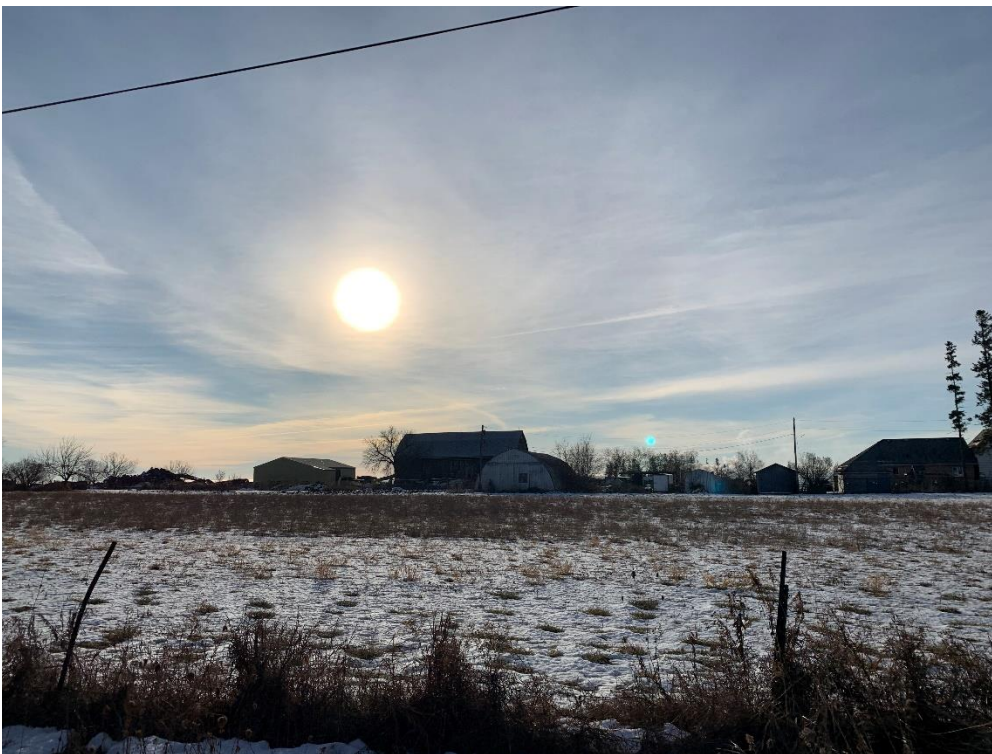
Photo 6: A view at the Farm Property / Contractor Yard located at 2939 Kirby Road.

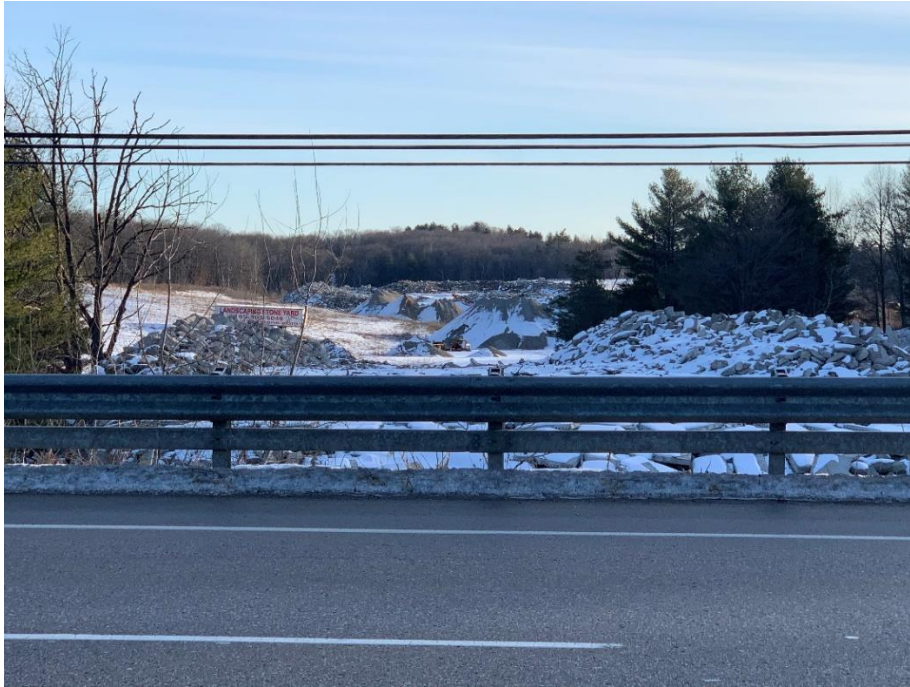
Photo 7: A view to the east from Dufferin Street at the quarry located at 11333 Dufferin Street.

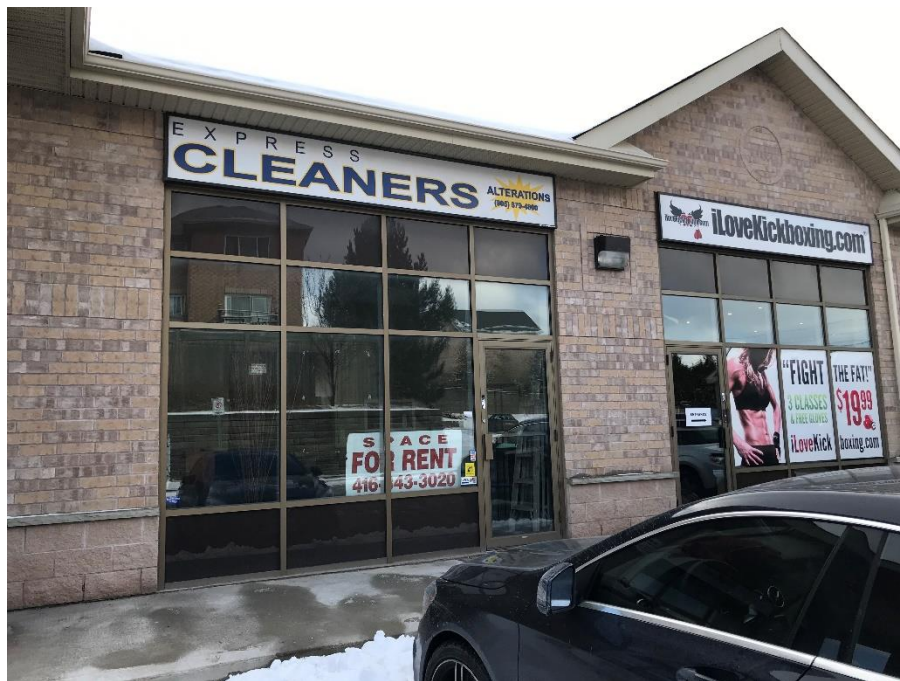
A former dry cleaner (Photo 8) was observed in the plaza to the southeast of Kirby Road and Keele Street with a municipal address of 11399 Keele Street. The dry cleaner was no longer in operation at the time of the Site Reconnaissance. The location of the former dry cleaner is approximately 160 m to the south of Kirby Road and east of Keele Street which is located

Photo 8: A view of the former dry cleaner at 11399 Keele Street – the plaza southeast of Kirby Road and Keele Street.

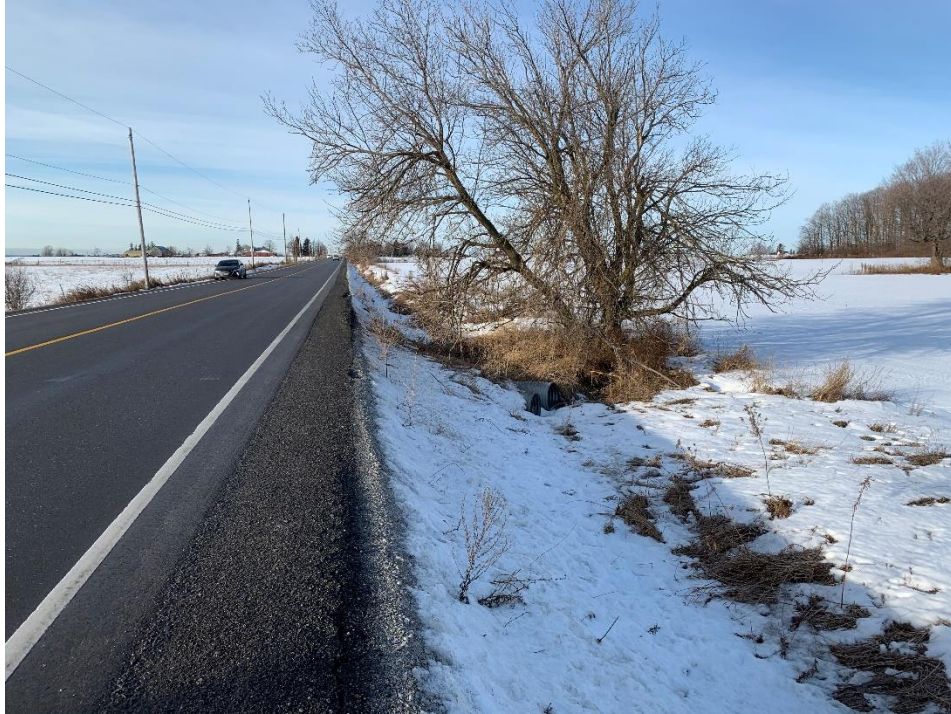
Storm water culverts were observed approximately 800 m to the east of Jane Street (Photo 9) beneath the Site alignment, and approximately 250 m to the west of Jane Street in the Study Area which convey surface water, however, no flowing water was observed in these culvert pipes at the time of the Site visit. Culverts were also present on the north and south sides of the Site alignment where intersecting roads and/or private driveways crossed the ROW to connect to Kirby Road. Although not visible due to the site relief and thick vegetation, a culvert or drainage channel may exist near the topographic low of the Natural Heritage System near Dufferin Street.

Photo 9: A view to the west on the north side of Kirby Road noting the culvert pipes that extend beneath the Site alignment.

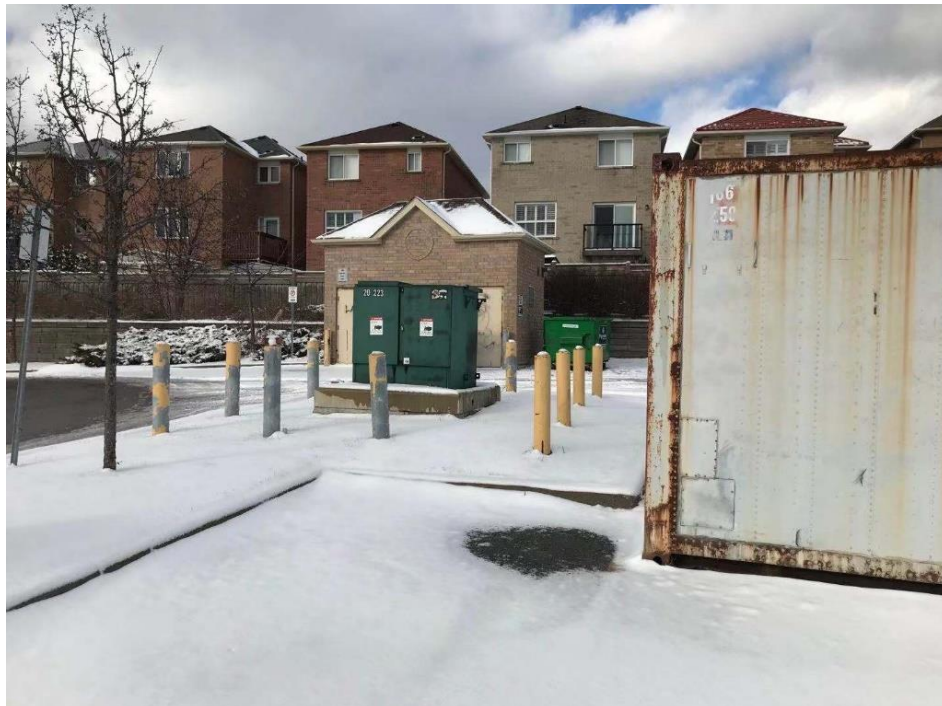
No pad-mounted transformers were observed within the Kirby Road ROW at the time of the Site visit, however, multiple pad-mounted transformers were observed in the residential subdivisions to the south of Kirby Road. A pad-mounted transformer in the plaza (Photo 10) was stained on an exposed portion of the box. Other transformers appeared to be in good condition. The general presence of these pad-mounted transformers is not expected to contribute to any APECs on the Site due to the distance and the downgradient location in relation to the Site alignment.

Photo 10: A view of a pad-mounted transformer at the plaza with the municipal address of 11399 Keele Street.
